Weekly Summary Report

USEPA Oversight, Sauget Area 2, Sauget, IL

WA No. 224-RXBF-05XX / Contract No. 68-W6-0025

Week Ending Friday October 31, 2003

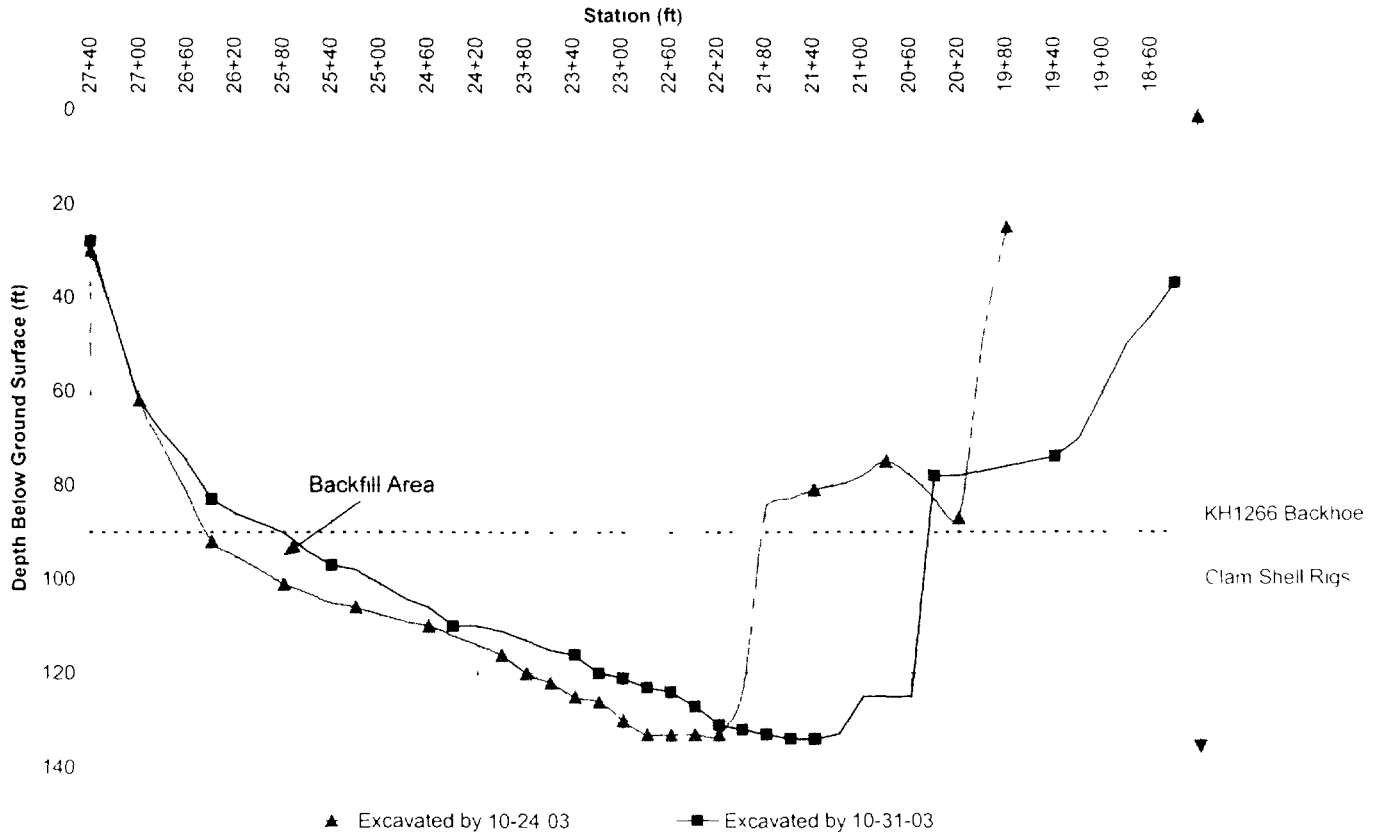
Graph 1

Weekly Barrier Wall Construction Progress
Oct. 27th to Oct. 31st 2003

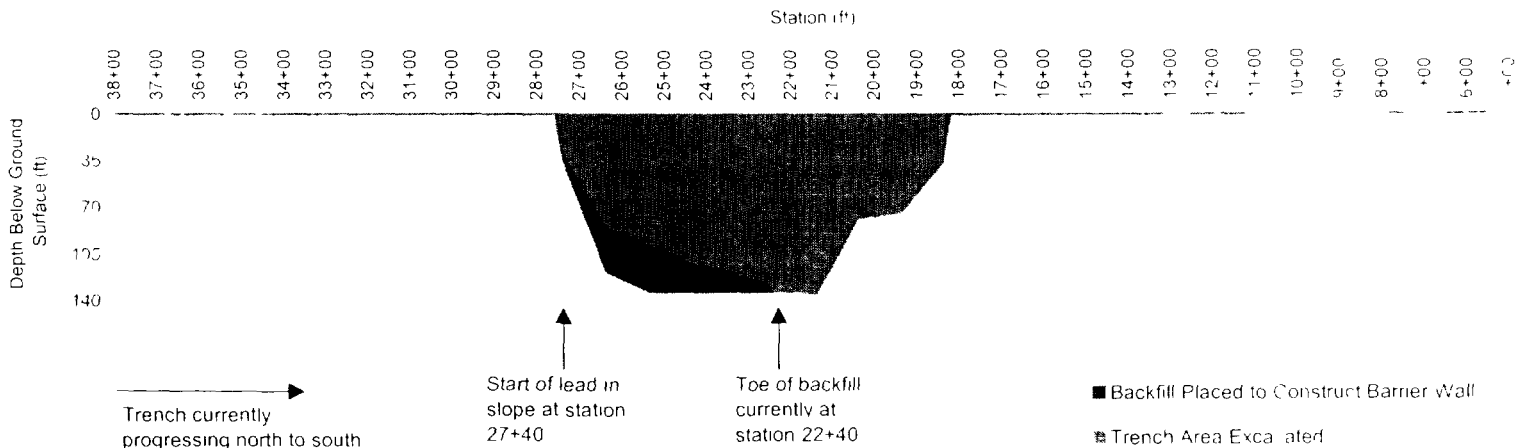
Graph 2

Barrier Wall Construction Progress by October 31, 2003
